Prepared For:

Kennett Square, PA, 19348

Inspection Details

Inspector Name: Edwin Dunckley
Company Name: Chester County Home Inspections, LLC
Company Address: 1357 Elbow Ln, Chester Springs, PA 19425

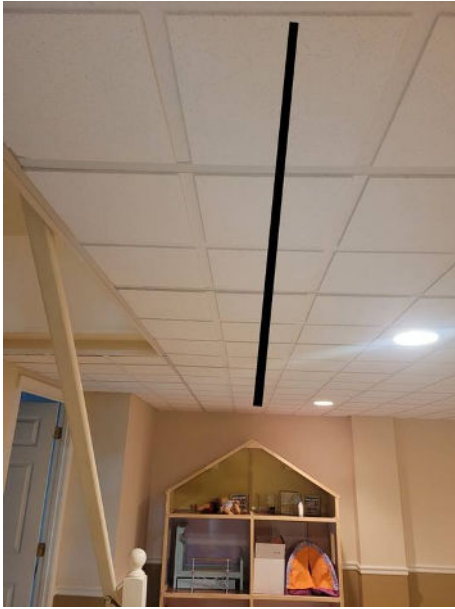
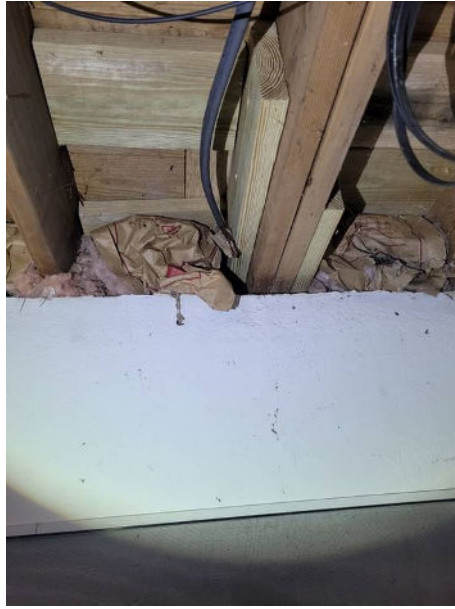
Previous foundation repairs were noted which likely shored up foundation and settling issues. I observed settlement of the floor from the entryway at the front door. In the basement, I moved a few ceiling tiles in the area of the sagging and noticed that joist were sistered. Even with the limited accessibility, the repair work seemed subpar. Those repairs could only be fully assessed if the ceiling tiles were removed over the full length of the affected joists. If the repairs concern you, then seek further information from a foundation expert after the ceiling tiles have been removed. I found other ad-hoc repairs (pictured). Then lastly, I will point out that many joists had been improperly modified by the electrician who installed the cables through the joists instead of underneath them. The number and size of the holes are unfortunate.

approximate area of floor structure deficiency

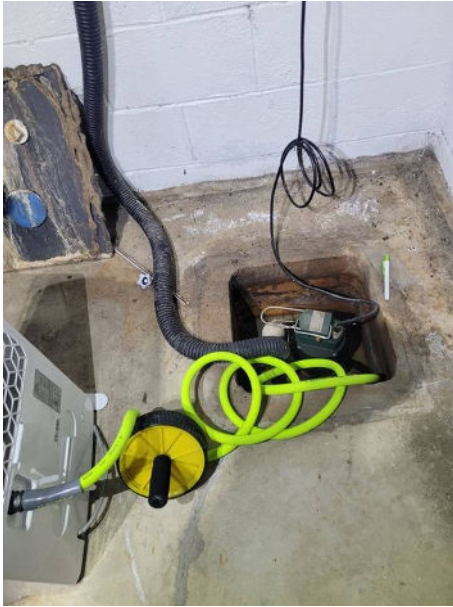
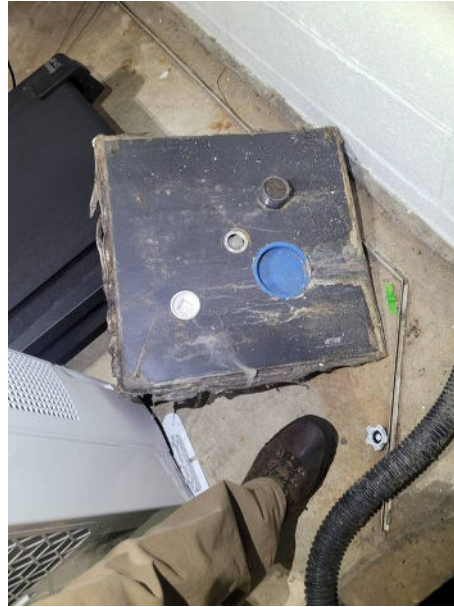
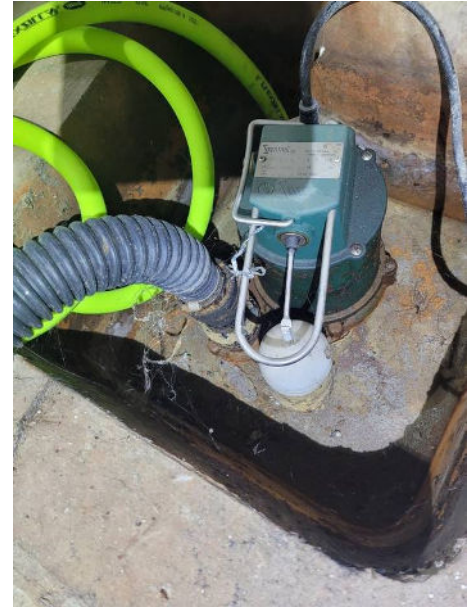
The sump output drain pipe did not have a one-way check-valve. A check-valve prevents discharged water from reentering the sump well. Recommend that a plumber install a check-valve.

The sump cover plate has been removed. The cover was originally sealed by the radon mitigator to ensure that the radon mitigation system can achieve sub-slab depressurization. I noted, however, that the drain tile do not extend into the sump crock as they do in newer homes, and therefore the sealing of the sump crock is of lesser importance. Nonetheless, I recommend installing a proper sump lid that will prevent accidents or injury.

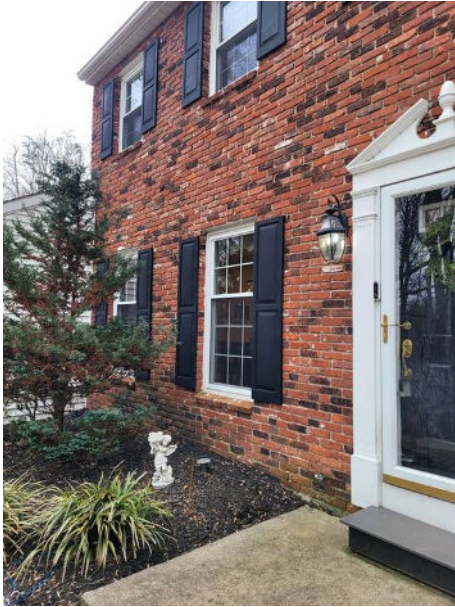
This wall is brick veneer. It is a single layer of brick anchored to the house exterior framing using brick ties, with provisions like weep holes, flashing, and an air gap to manage moisture and protect the structural frame. This method ensures durability and aesthetic appeal while maintaining the integrity of the home's structural system. But sometimes things go wrong which cause that veneer wall to separate from the building. It could be that the brick ties pulled loose from the house sheathing, or the sheathing pulled loose from the house framing. When that happens, the wall will eventually fall away from the house unless it is stabilized. I observed that this wall was stabilized using tension rods.

Tension rods are structural reinforcement tools used to stabilize walls at risk of detaching from a building due to compromised structural integrity. Commonly employed in barns, homes, and other structures, these rods address issues caused by factors such as soil erosion, mortar degradation, or significant settling. The system typically involves large plates installed on the exterior of the wall, with rods or cables connecting to the opposing wall or internal structural members. By tightening the rods, the setup counteracts outward forces, preventing further separation and preserving the building's stability.

A veneer wall is not structural but of course it needs to be preserved. My assessment is that this veneer wall started to pull away (or was at risk of pulling away) and was re-anchored to the house framing with anchor rods. Note that the same wall continuing to the left of the front door did not need this repair. *In my opinion, this is a perfectly good fix and I found no signs that suggest otherwise.* I am listing this as a Defect issue ONLY to get your attention to the matter, not because I believe there is an issue that needs to be resolved. You need to know, so I had to explain. If you have any reservations about this issue, please consult with a structural engineer.

No tension rods on this side

Note four anchors

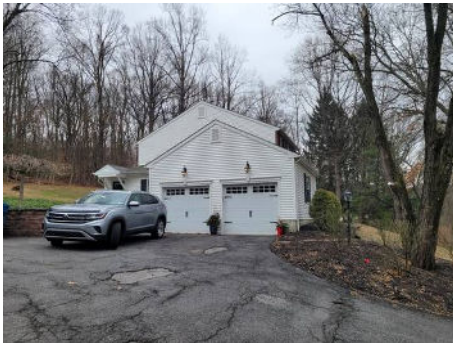
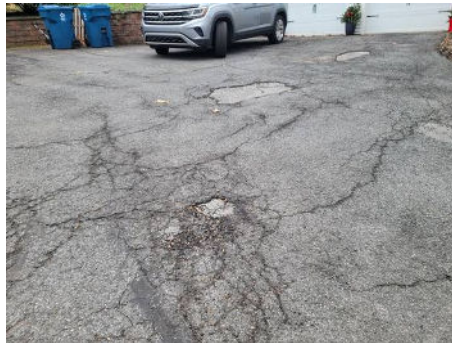
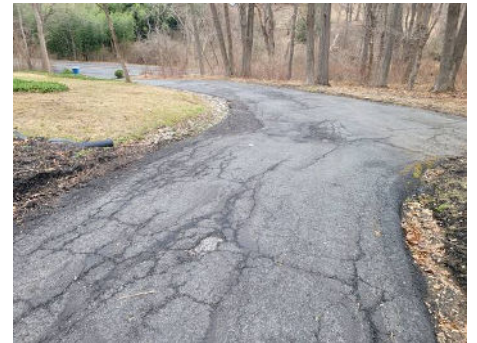
The driveway was not properly installed. A thin coat of asphalt was installed over a previous driveway but the installer cut corners too far - it was not thick enough to last. Consult with a driveway installer for repair options. Ideally the last coat should be removed, not just covered over.

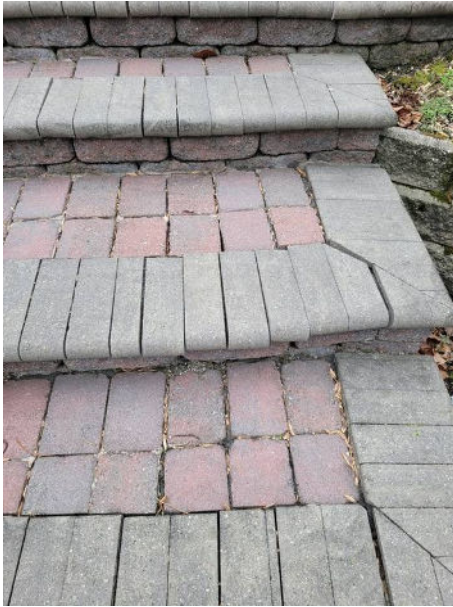
Pavers have settled due to inadequate substrate preparation and poor installation practices such as relying on epoxy. Some pavers are loose which is a fall hazard. Hire a landscaper or hardscaper to re-set the pavers.

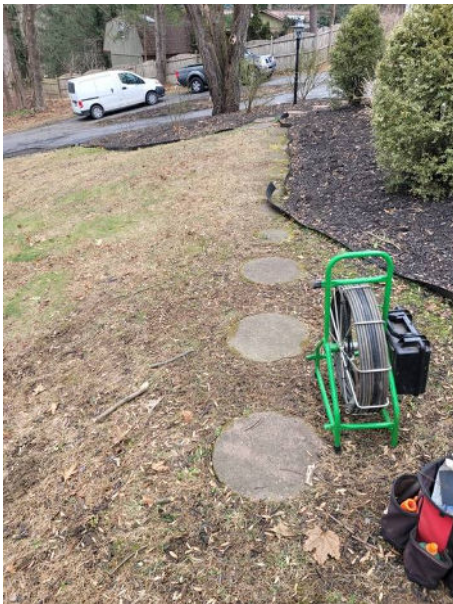
The walkway to the front door has been taken over by excess mulch and overgrown vegetation. The plastic barrier that was installed as a separator from the gardening area is inadequate. Hire a landscaper to reclaim the walkway.

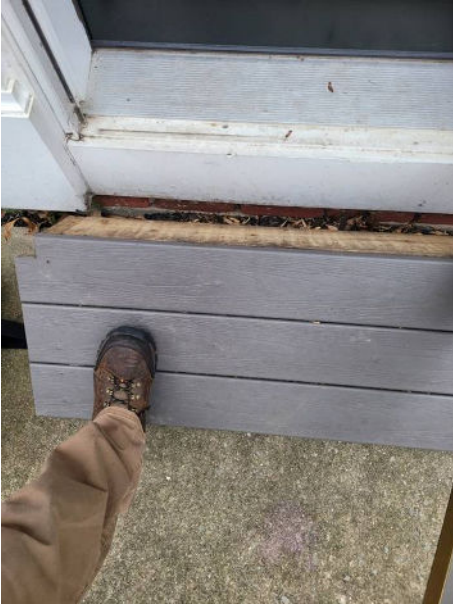
The step from the landing to the front door is loose. I tripped on this on my first entry into the home. But

furthermore, this step was too low. It should equally divide the height from the landing pad to the threshold of the door. Steps must have uniform rise, even for just two rises as in this single step. Hire a general contractor to modify or repair this step, and to attach it to the wall.

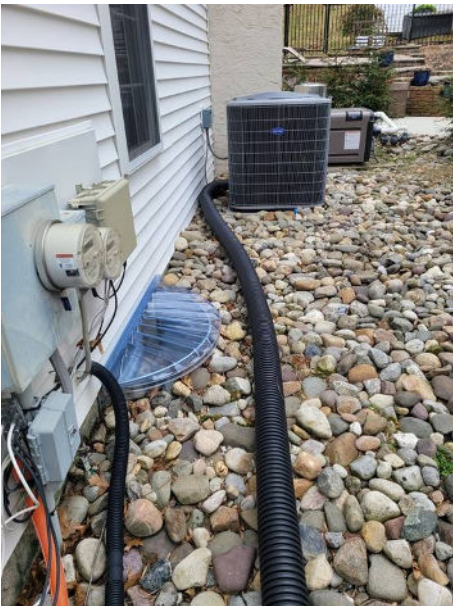
It is difficult to assess grading accurately when covered with dense ground-cover plants, mulch, gravel or snow. If appears that the soil is sloping towards the home in this area, which could lead to water penetration. Consider updating the landscaping to have positive grading.

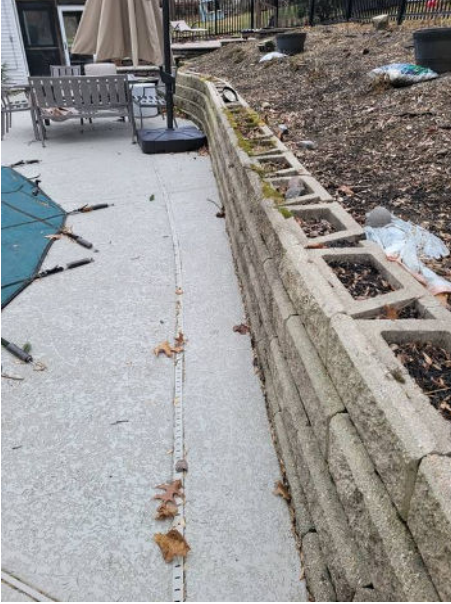
The back of the house is situated on a hill. A wide path had been graded nearly level, with retaining walls to stabilize. I did not see a drainage system near the top of the retaining walls but it appears that water is effectively kept at bay since the house foundation did not show signs of water penetration. Ensure that the retainer wall is maintained.

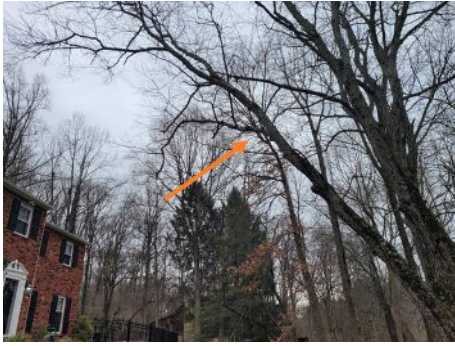
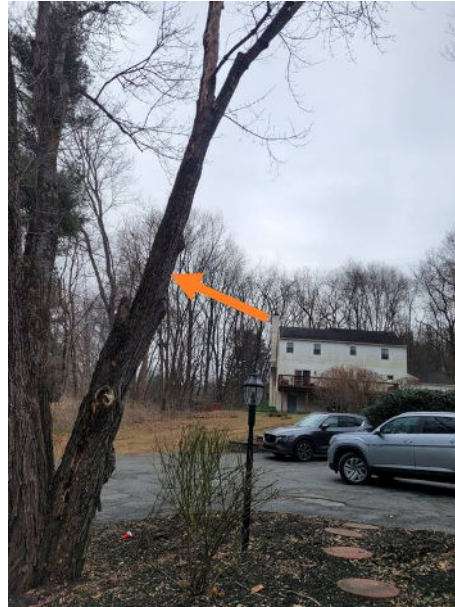
The indicated branches pose a risk to the house or property. Consider proactive removal.

dead branch

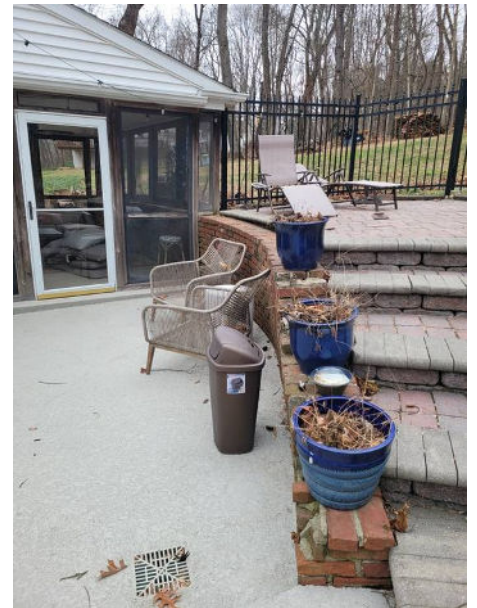
A guardrail is required at all locations where there is a 30-inch or more drop from one surface to another. Hire a fencing specialist to install guardrails where required.

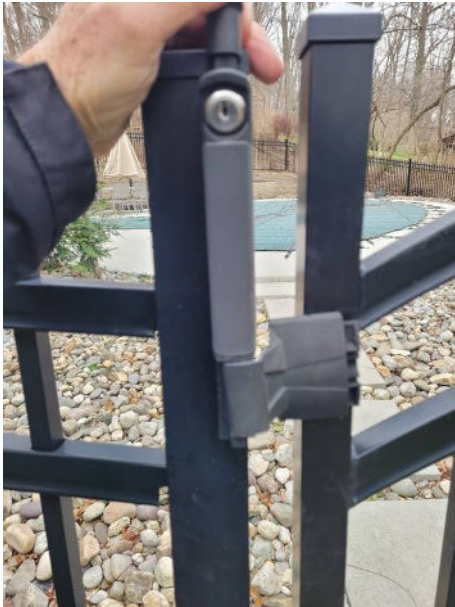
There is settlement at the pool fence which caused the front gates' lock and latch to be out of alignment. These latches are adjustable to compensate for anticipated movement. Have the gate lock and latch adjusted to ensure that the pool area can be properly secured. Pool safety is paramount.

We did not perform a Pool Inspection at this time. We noted a **priority defect** that should be addressed - the pool cover is severely weathered and would not sustain the weight it was designed to accommodate. That is a safety hazard. Please contact us for a detailed pool inspection.

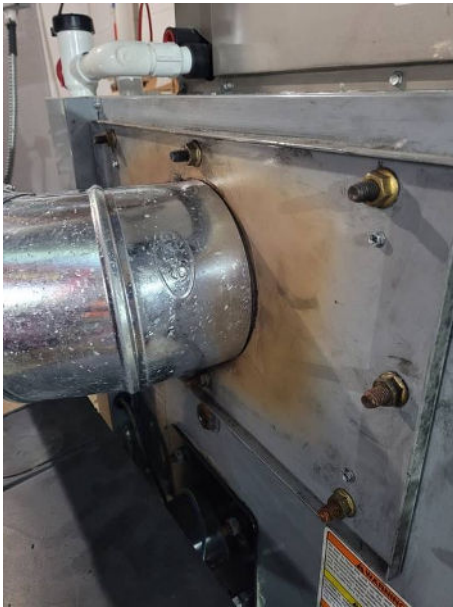
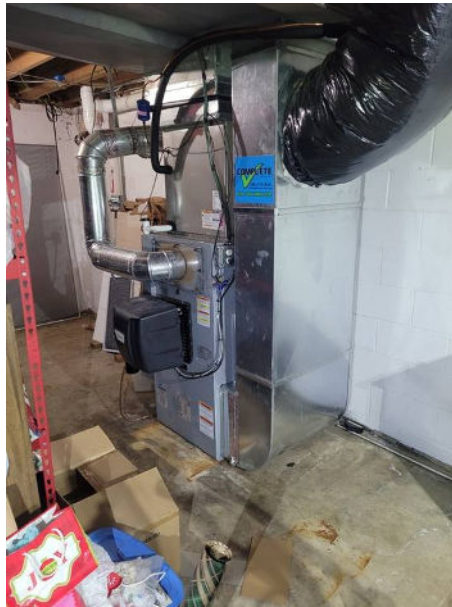
The furnace has indications that blowback occurs. This is when hot exhaust gas does not exit into the chimney but blows back into the interior. The cause could be due to inadequate sealing at the exhaust flange, or blockage in the exhaust pipe or chimney flue, or both. The effect is that exhaust gas enters the home, and that gas contains carbon monoxide (CO) which can be deadly. Hire an HVAC specialist to correct the problem.

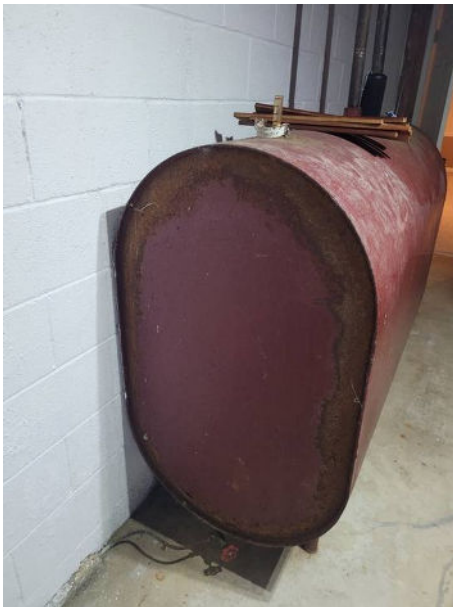
The oil tank is corroding. The visible corrosion is on the outside suggesting that the basement has high humidity with inadequate airflow over much of its lifetime. Consider repainting after cleaning to extend life. Be advised that oil delivery companies need to inspect the oil tank when establishing new contracts, and that they might declare this tank as unacceptable.

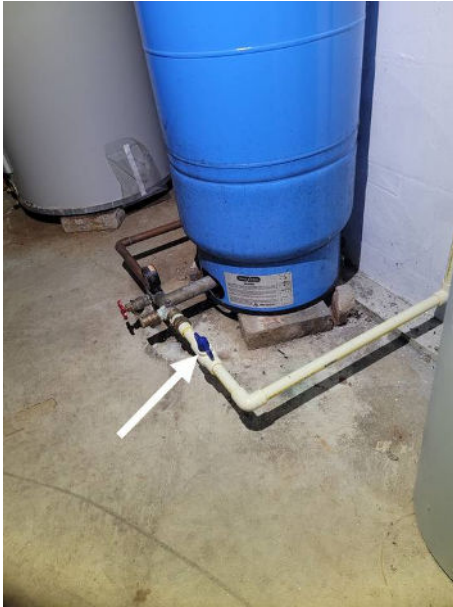
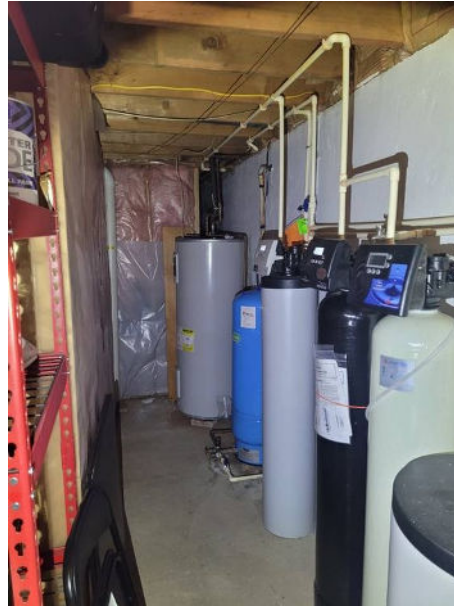
At pressure tank, Basement

The main shutoff for the water supply is indicated in the photos.

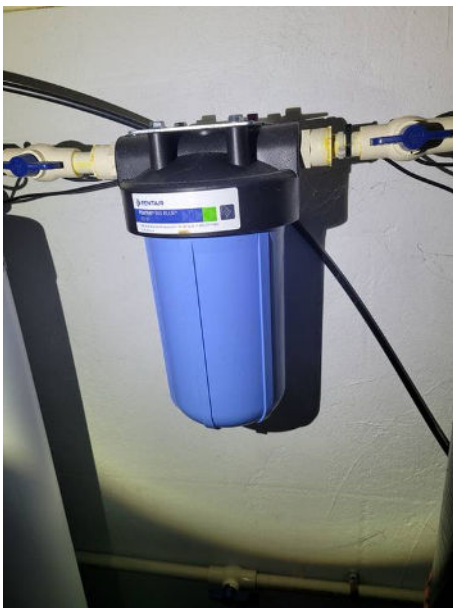
Sediment filters need replacement when they become clogged. The sediment filter cover is opaque (nontransparent), consequently you cannot assess its condition without opening it. Consider replacing with a clear filter cover.

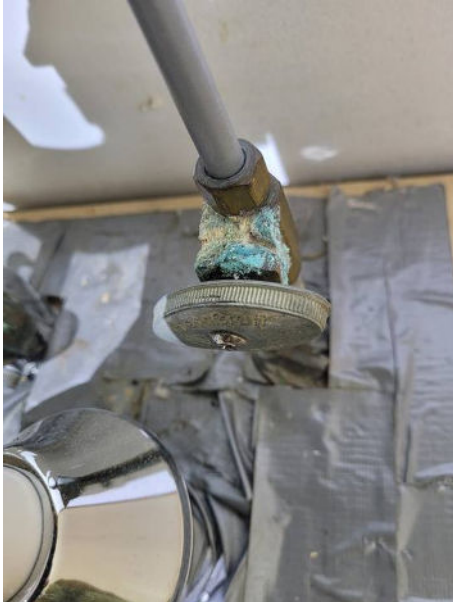
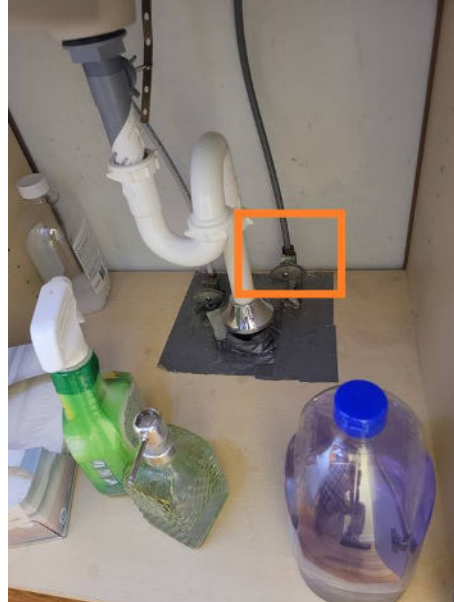
I observed mineral deposits on plumbing fittings which we attribute as micro leaks. A micro leak is so small that it often does not appear to be leaking or get wet on the outside, yet mineral deposits from the evaporation of the water indicate that it leaks. This leak is generally cosmetic but should be addressed eventually as it could grow into a larger leak over time. Recommend proactive fixing before it becomes problematic.

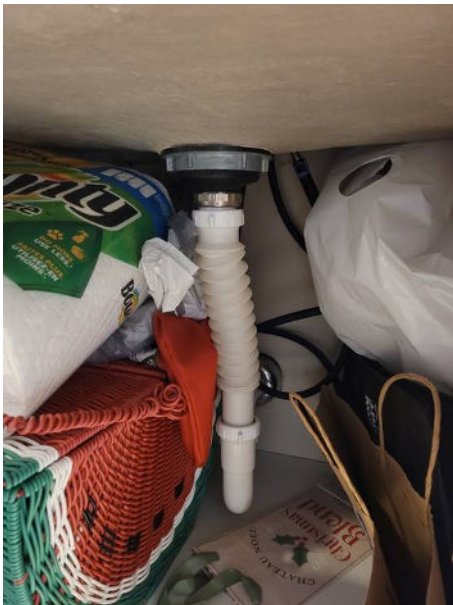
Corrugated drain pipe. The sink has an unapproved, flexible, corrugated drain pipe. These pipes are installed by non-professional plumbers as convenience. They often contribute to blockages. We do not endorse it. Consider hiring a plumber to improve this plumbing.

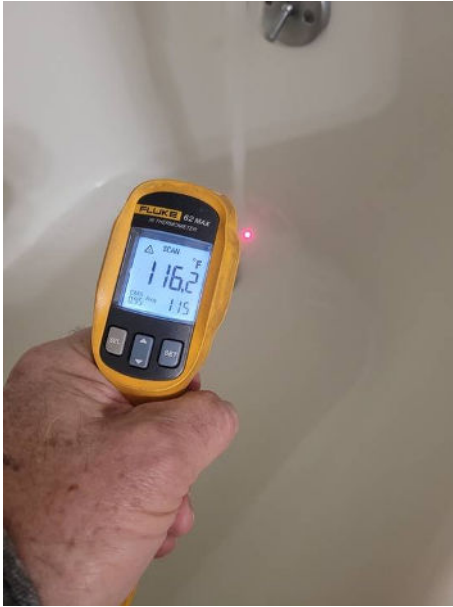
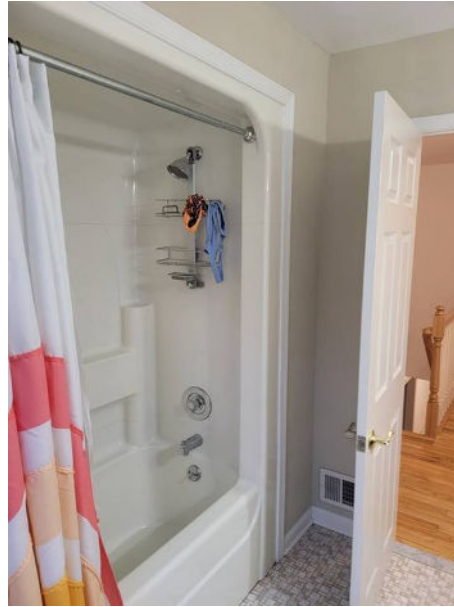
Scalding water. The temperature at the tub exceeds the recommended maximum of 100°. This is a scalding hazard for small children. Recommend that you hire a plumber to adjust the thermostatic control valve in the tubs / showers. A thermostatic valve mixes cold water with the hot water to temper the output. [Note - the issue is not the water heater, which is typically set around 120°-140°. It is the adjustable setting of the thermostatic valve at the tub.]

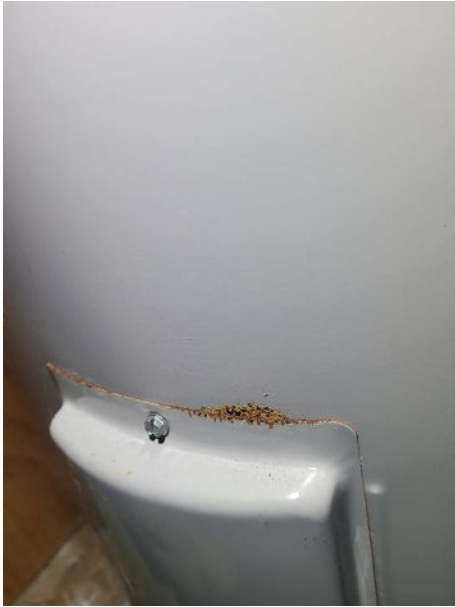
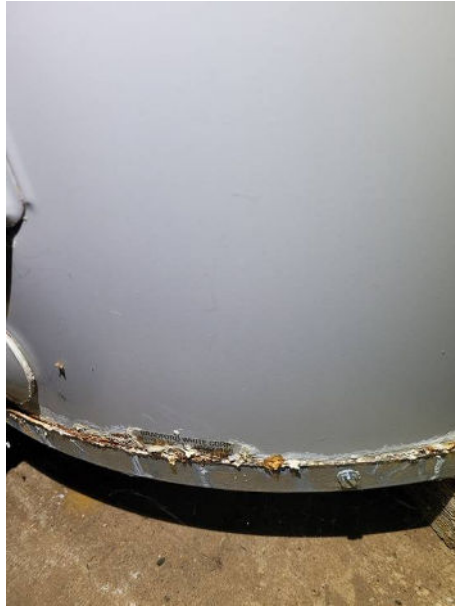
The water heater was manufactured in 2013.

A typical water heater life expectancy is 10-15 years. This unit is nearing the end of its useful life. It has signs of internal leaking. I recommend proactive replacement since failure with leaks is likely.

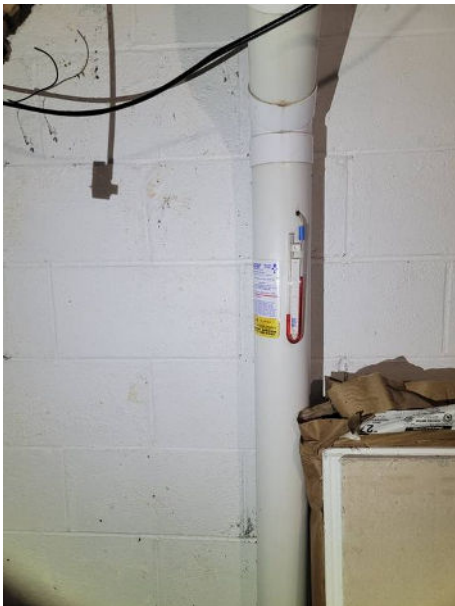
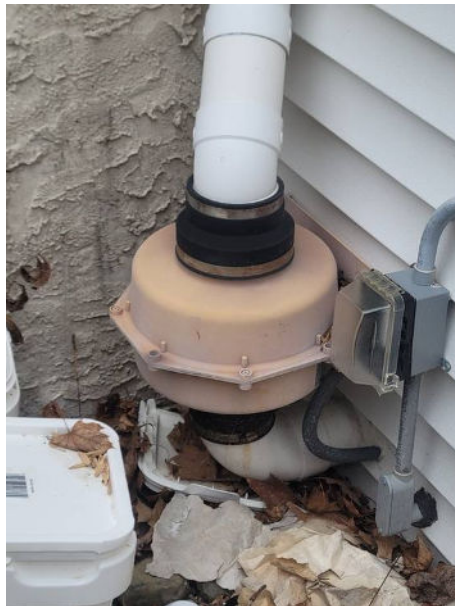
The home has a radon mitigation system. It is a sub-slab depressurization type. The fan was running as can be seen on the manometer. The PA Dept. of Environmental Protection recommends re-testing for radon every two years. We did not perform a radon gas test during this inspection.

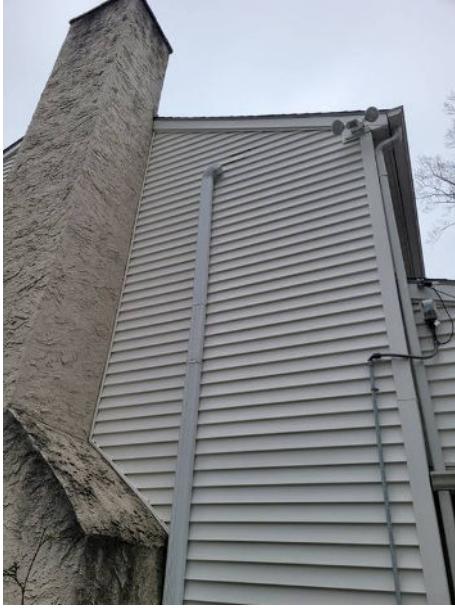
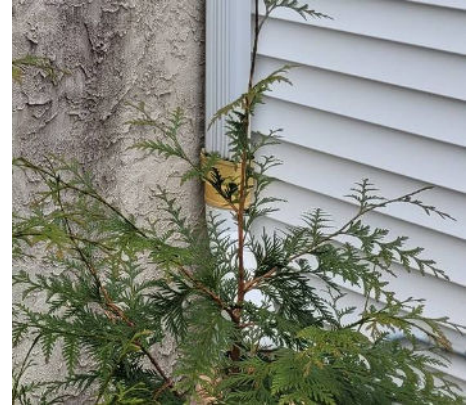
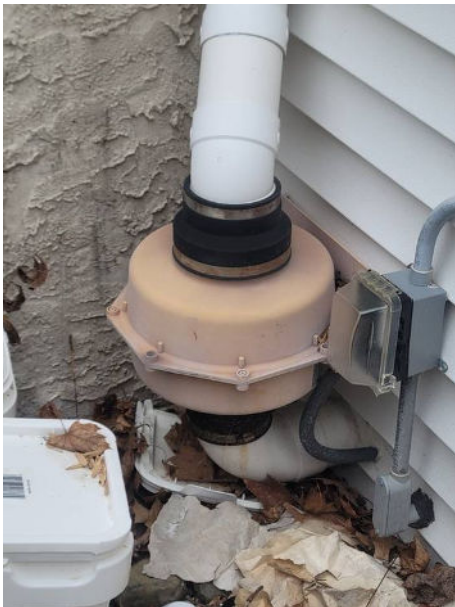
EPA's Radon Mitigation Standards require vent discharge points to be above the roofline. This radon pipe ends below the roofline. The risk is that concentrated radon gas removed from the basement can enter through a window. In addition, the vent pipe is gutter pipes, using a PVC-to-gutter connection near ground level. There is a lot of air leakage under pressure from the pump at that location. Concentrated levels of radon are delivered near windows. This is not a professional installation. Hire a radon mitigation professional to remedy.

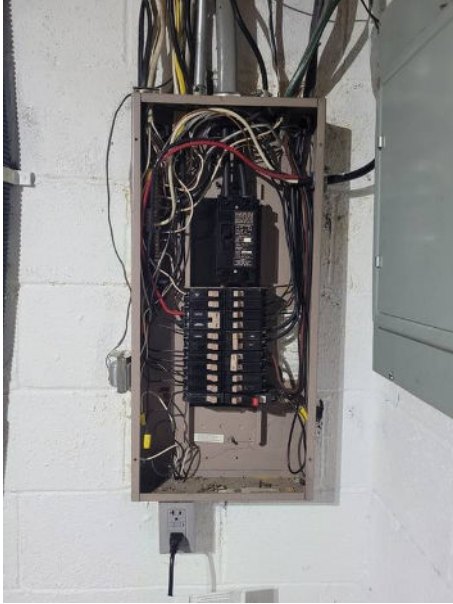
Incorrect types of screws were used at the electrical panel cover (deadfront). This could be potentially hazardous if the

screws puncture a live electrical wire. Proper panel cover screws are fine threaded and blunt. Replace with appropriate deadfront screws available at hardware stores.

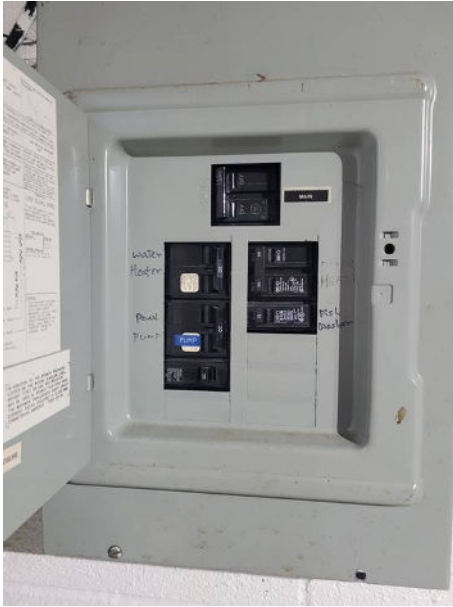
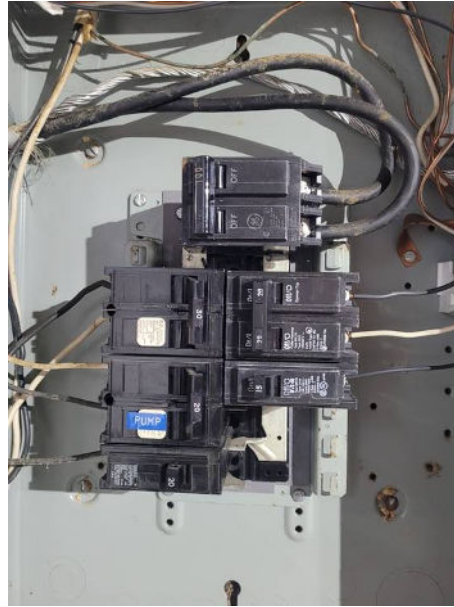
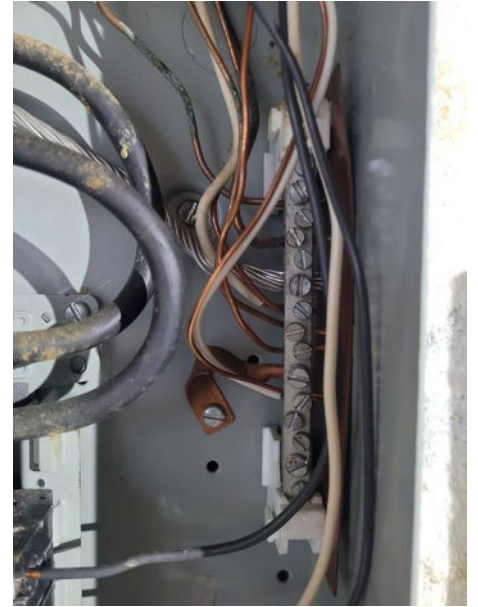
The neutral conductor (white or grey wire) and the equipment ground conductor (bare or green wire) were bonded together at the sub panel. This permits electricity to flow on ground conductors. Neutral conductors must be kept separate from the equipment ground conductor, they must be isolated from the sub panel metal enclosure, and the equipment ground conductors must be bonded to the sub panel metal enclosure. This is a fairly common problem but easy to fix. I recommend that an electrician remove the bonding.
(The newer subpanel was wired correctly.)

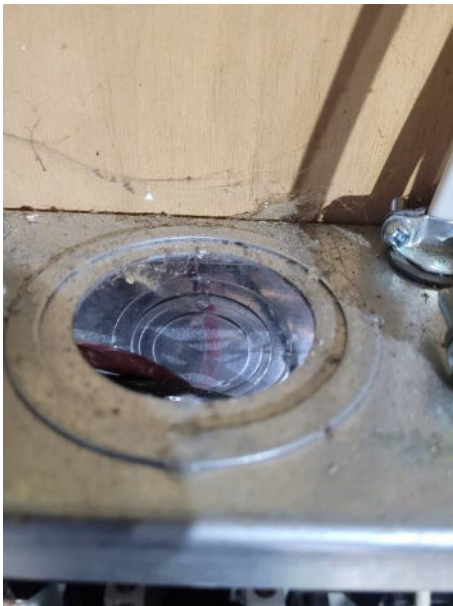
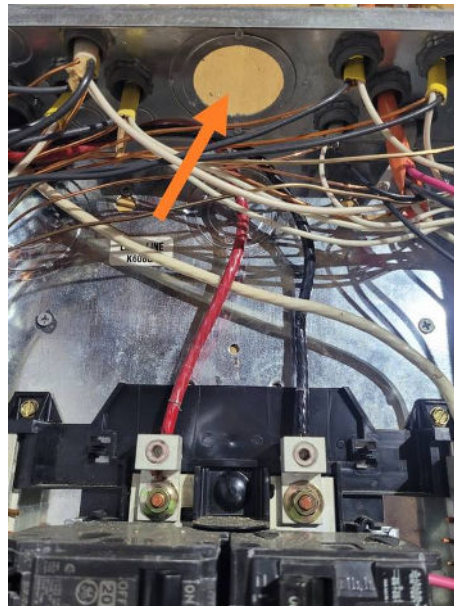
This panel has an open knockout. This is the secondary (newer) subpanel. The issue with an open knockout is that a metal object that falls in, such as a screwdriver, could cause a direct short. Have an electrician install a blocking plate.

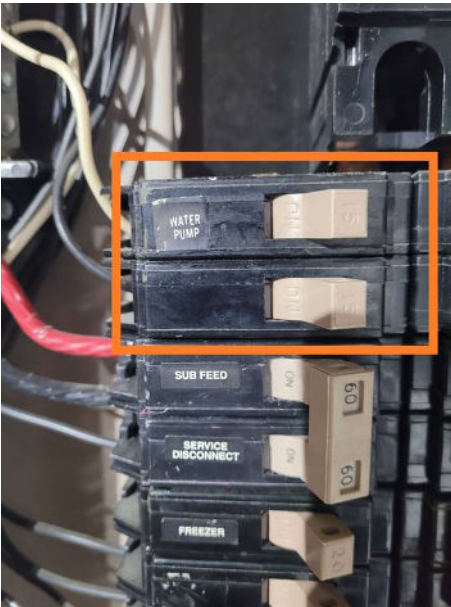
Missing breaker tie. The well pump is a 240-volt service, but the two breakers are not interconnected with a breaker tie. (For comparison, note the double-breaker below these two where a breaker tie is present.) As is, it could permit one of the two breakers to trip while the other remains on, thus providing 120-volt service to the pump that requires 240 volts. This can give the false appearance that it is not working, or it could cause the pump to fail. This must be corrected.

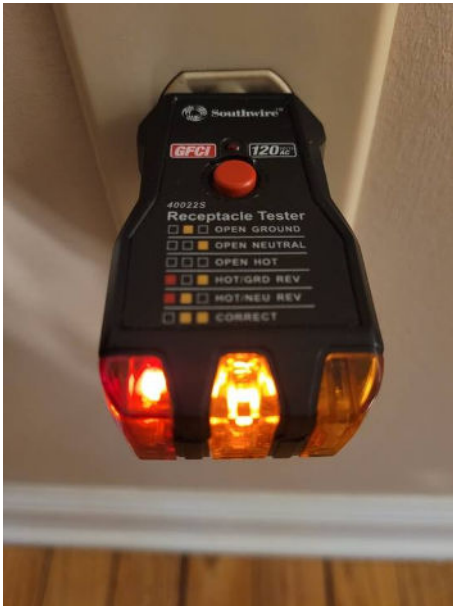
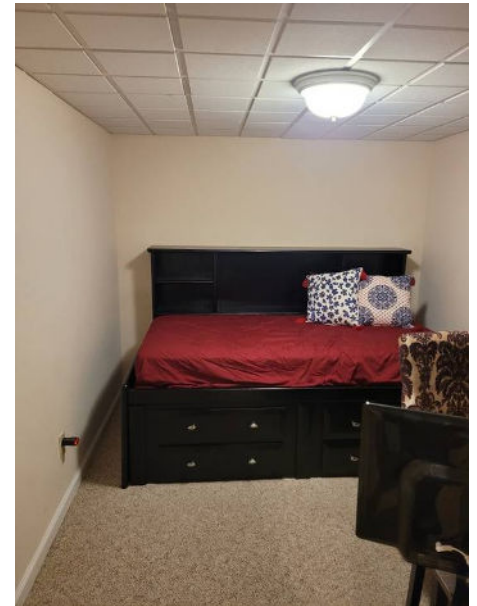
A wall receptacle was wired with reversed polarity or open neutral. A reverse polarity condition will cause current to flow on the neutral conductor which is a shock hazard. The open neutral condition will cause current to flow on the grounding conductor, which creates the possibility of an electrical shock at the ground connector of *any* outlet in the home. This condition **must** be fixed. Hire an electrician to resolve.

one receptacle in this room

all receptacles in this room

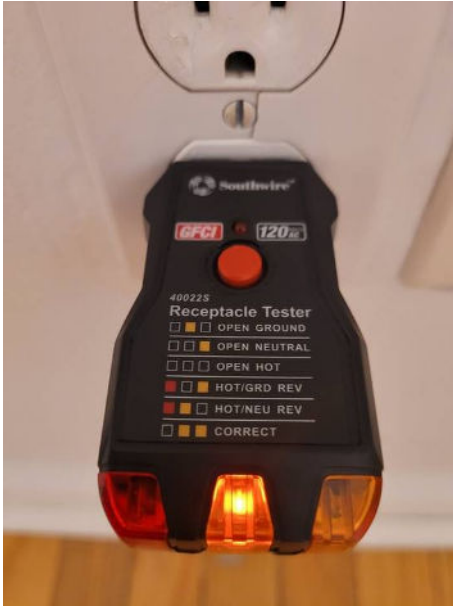
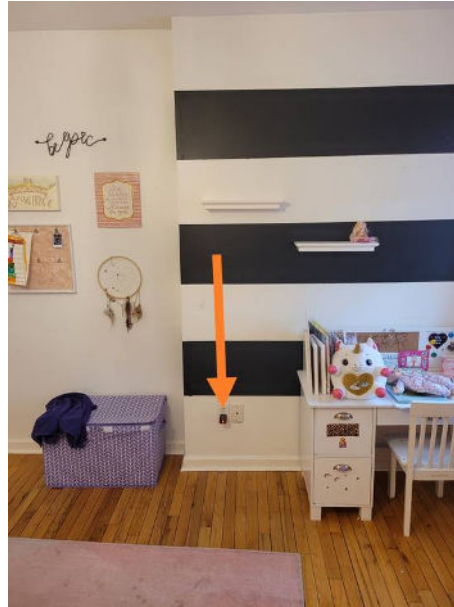
Ungrounded receptacle. One or more wall receptacles tested as being ungrounded. This is a potential electrical hazard. This problem only occurred in the shown location. The wall receptacle apparently has a disconnected ground connection.

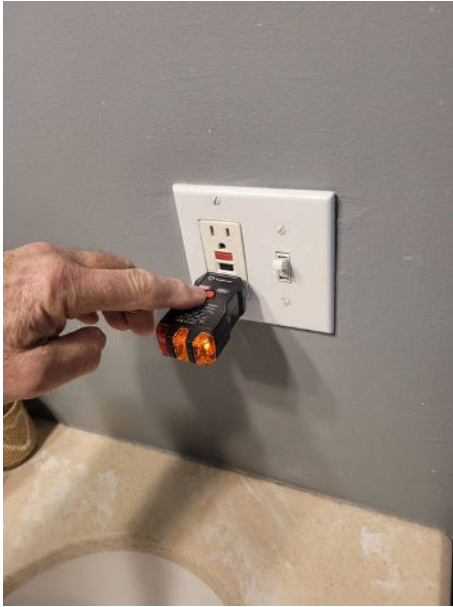
It's important to note that the requirement is to protect certain receptacles with GFCI protection, not to install a GFCI device at every receptacle. This misunderstanding often leads to unnecessary GFCI installations, such as in this case.

location is primary bathroom

To resolve the issue, remove the identified defective GFCI device since the branch circuit already has GFCI protection upstream in the daisy chain. To ensure compliance, affix a label or mark the outlet as "GFCI Protected Outlet."

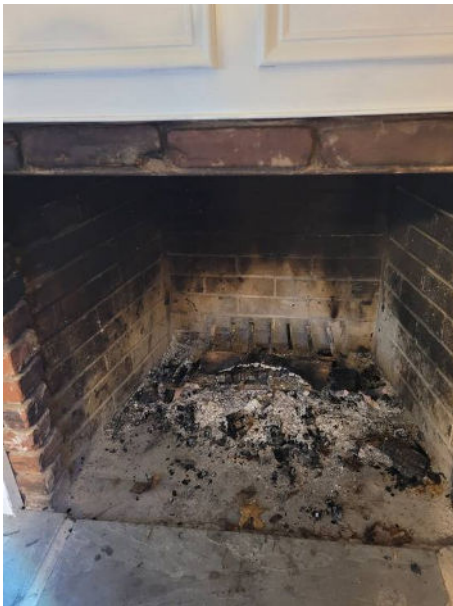
This information is offered as FYI. Open fireplaces often *increase* your heating cost. They are inefficient because a large volume of heated air is sucked out in the draft of the fire. Also, the chimney dampers are most often left open during heating season because most people forget to close the damper after the fire had gone cold.

An open fireplace can be converted to a closed fireplace with a fireplace insert, which is a wood stove that fits inside the fireplace. It still gives you the benefit of ambiance and radiant heat, but it eliminates the wasteful draft up and out the chimney. It has two primary benefits:(1) minimize heated air loss because it has draft control, and (2) harvest heat from the firebox to heat the room. The same fireplace with a fireplace insert could be a valuable heating device to *lower* your heating cost. Alternatively, at a lower investment cost, consider installing fireplace glass doors. They help to reduce air loss. Consult with fireplace vendors for more information.

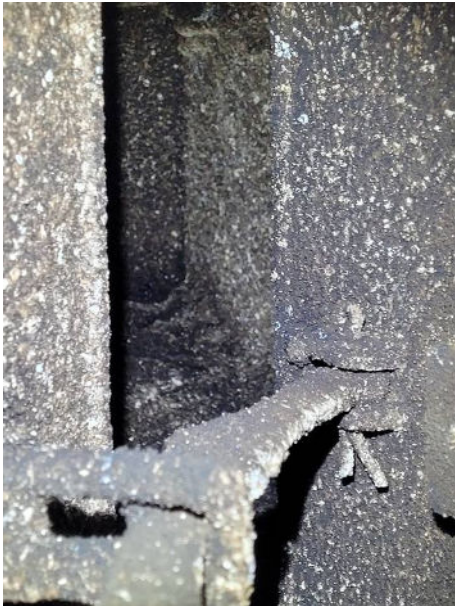
There is thick soot in the smoke chamber. Hire a certified chimney sweep to clean and inspect the interior of the fireplace and chimney system before first use, and then annually as part of your ongoing maintenance.

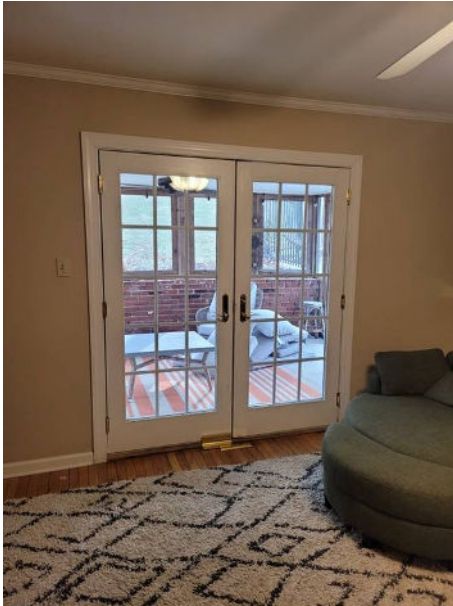
The door does not latch as it is supposed to, you have to lift the handle to free the latch. It is supposed to latch like any other door by simply closing it. I recommend that a door installer adjust the door latch and lock mechanisms.

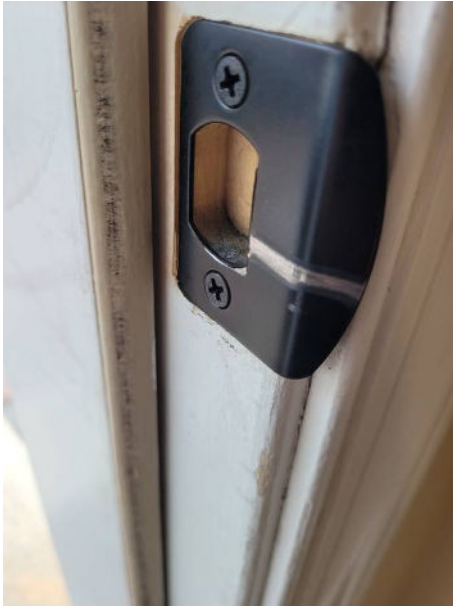
The door does not latch as it is supposed to because the latch does not align with the strike plate. This occurs over time due to minor settlement. Have a handyman or door installer adjust the strike plate. In current condition, the door can only be held closed by the deadbolt.

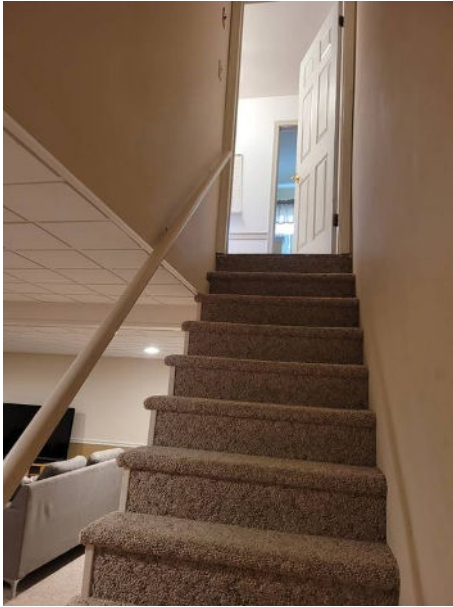
Three-way lighting is missing at the stairs. It is a standard requirement to have 3-way switches at the top and bottom of the stairs to turn lights on and off.

should have a switch about there

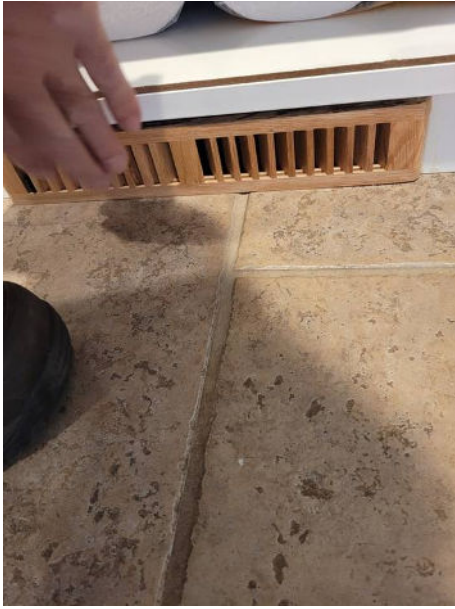
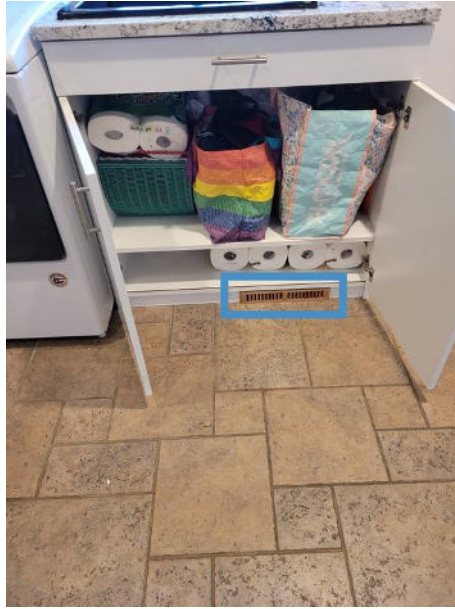
The laundry room has minimal air supply for heating because a cabinet was installed over a register location, with only minimal opening at the kick plate. The better option would have been to relocate the duct supply to the open floor area. Also, I did not find a return vent from this room. Airflow will be minimal with the room door closed. If heating this room proves to be problematic (expected to be) then hire an HVAC specialist to relocate the supply register and add a return.

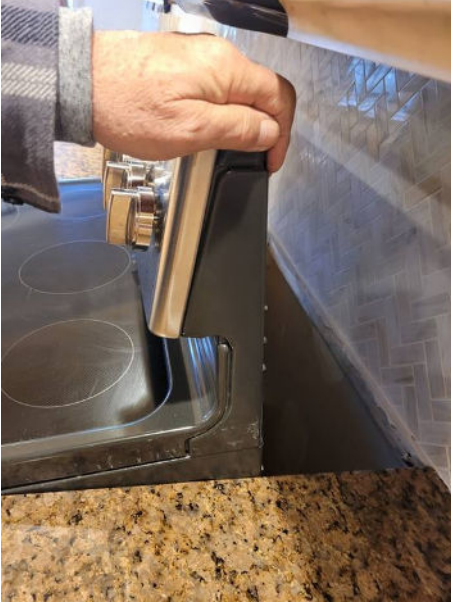
The oven/range was not fastened to the floor. This poses a safety hazard to children if the oven door is left open while hot food is cooking on top. This is a newer range and would have come with the bracket, which is listed as a required installation step. Recommend correction by installing an anti-tip bracket to secure the range.

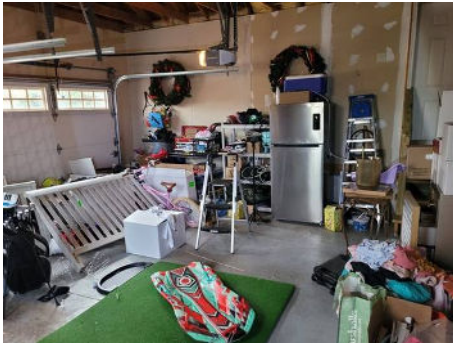
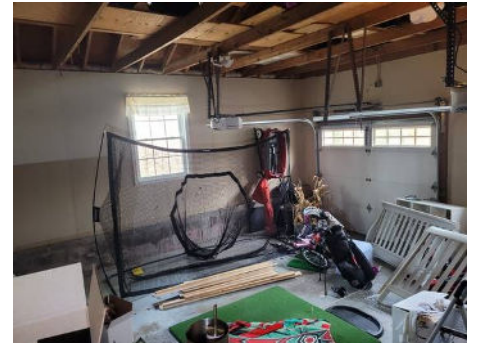
Personal storage restriction. Stored items limited my visual inspection. Moving personal items and storage is not required by the Standards of Practice. I could not see everything.

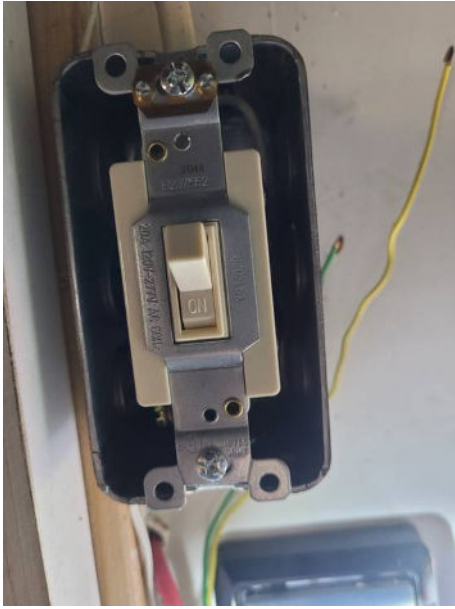
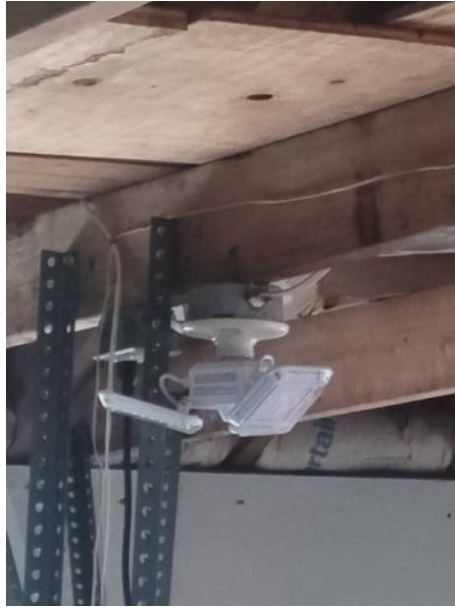
The light switch did not have a faceplate cover. Also, the light did not work - possibly the light bulb expired.

I could not inspect the receptacles since they were blocked by the stored items and the refrigerator. Given that this home is older, those receptacles are probably not GFCI protected, and if that is the case, then consider upgrading to GFCI for general safety as is now done for newer homes.
